Correlation Of Beam Transport Characteristics And Mass Resolving Power To Analyzing Magnet Pole Piece Wear In Axcelis HE Ion Implanters

Ron Johnson¹, John Schuur¹ and Randy Tysinger²

Abstract. An investigation into odd analyzing magnet tuning behavior on an Axcelis HE ion implanter revealed a correlation to excessive wear on the analyzer magnet pole pieces. Though the lifetime is generally quite good, the pole pieces are internal to the beamline design and are exposed to and sputtered by the ion beam during mass analysis. This erosion of the pole piece surfaces affects beam focus and transport, especially for lower current ion beams. Eventually, automatic beam set-up fails altogether as the system is unable to locate the correct amu peak. It is important to understand and correct any deficiencies in pole piece condition as long-term neglect will eventually lead to process errors. Data is presented to illustrate good and bad pole piece condition and a method is suggested for non-invasive testing.

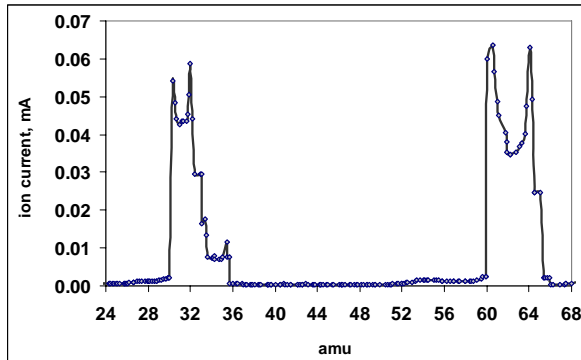
beam current was correct, etc). For the ion implanter in question, a daily sheet resistance monitor was processed which also used Phosphorous; this monitor process had approximately 10x ion current v. the process with amu tuning problems. Eventually, consistent failure to low amu inspired more investigation, including on-board tool SPC, IDL review and review of amu spectrums. Figure 1 is analyzer spectrum data from an HE machine with the amu tuning problem. For both monoatomic and diatomic Phosphorous there is a ‘horns’ phenomena in the spectrum that has peaks above and below the target peak amu. (+/- 1 amu for $^{31}\text{P}^+$ and +/- 2 amu for $^{31}\text{P}_2^+$).

FIGURE 1. An illustration of the ‘horns’ phenomena observed for both $^{31}\text{P}^+$ and $^{31}\text{P}_2^+$ on an HE implanter.

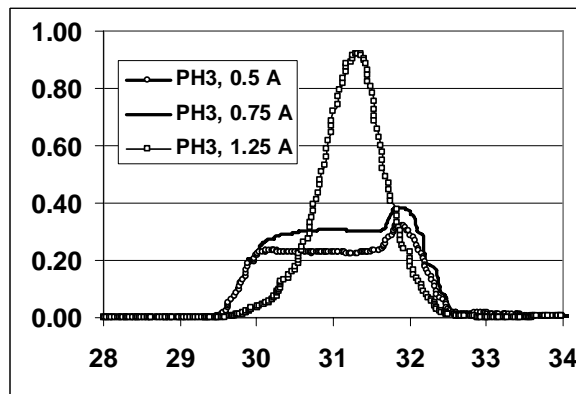
FIGURE 2. Change in PH3 amu spectrum for affected HE machine as a function of Arc Current.

Both Figures 2 and 3 show a clear dependence on Arc Current with respect to evolution of amu peak mismatch. It should be noted that this data was generated simply by varying Arc Current with all other source parameters, such as: Arc Volts, Gas Flow, Source Magnet, Suppression Voltage, etc. were held constant.

The data in Figures 2 and 3 inform us that the problem will be masked for many process set-ups – as beam current (Arc Current) increases, the problem with peak location is reduced.

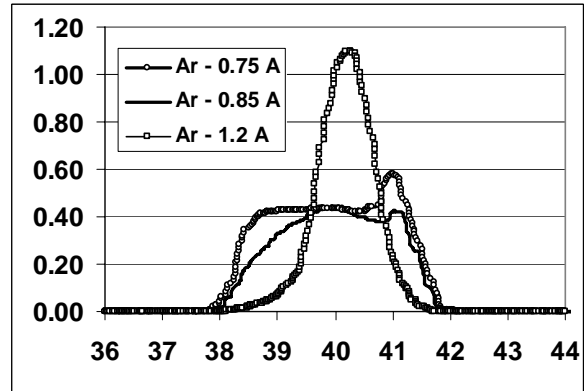
FIGURE 3. Change in Argon amu spectrum for affected HE machine as a function of Arc Current.
